# ANNUAL REPORT FOR 2002

**Bridge Maintenance Mitigation Site**

**New Hanover County**

**Project No. 8.2250109**

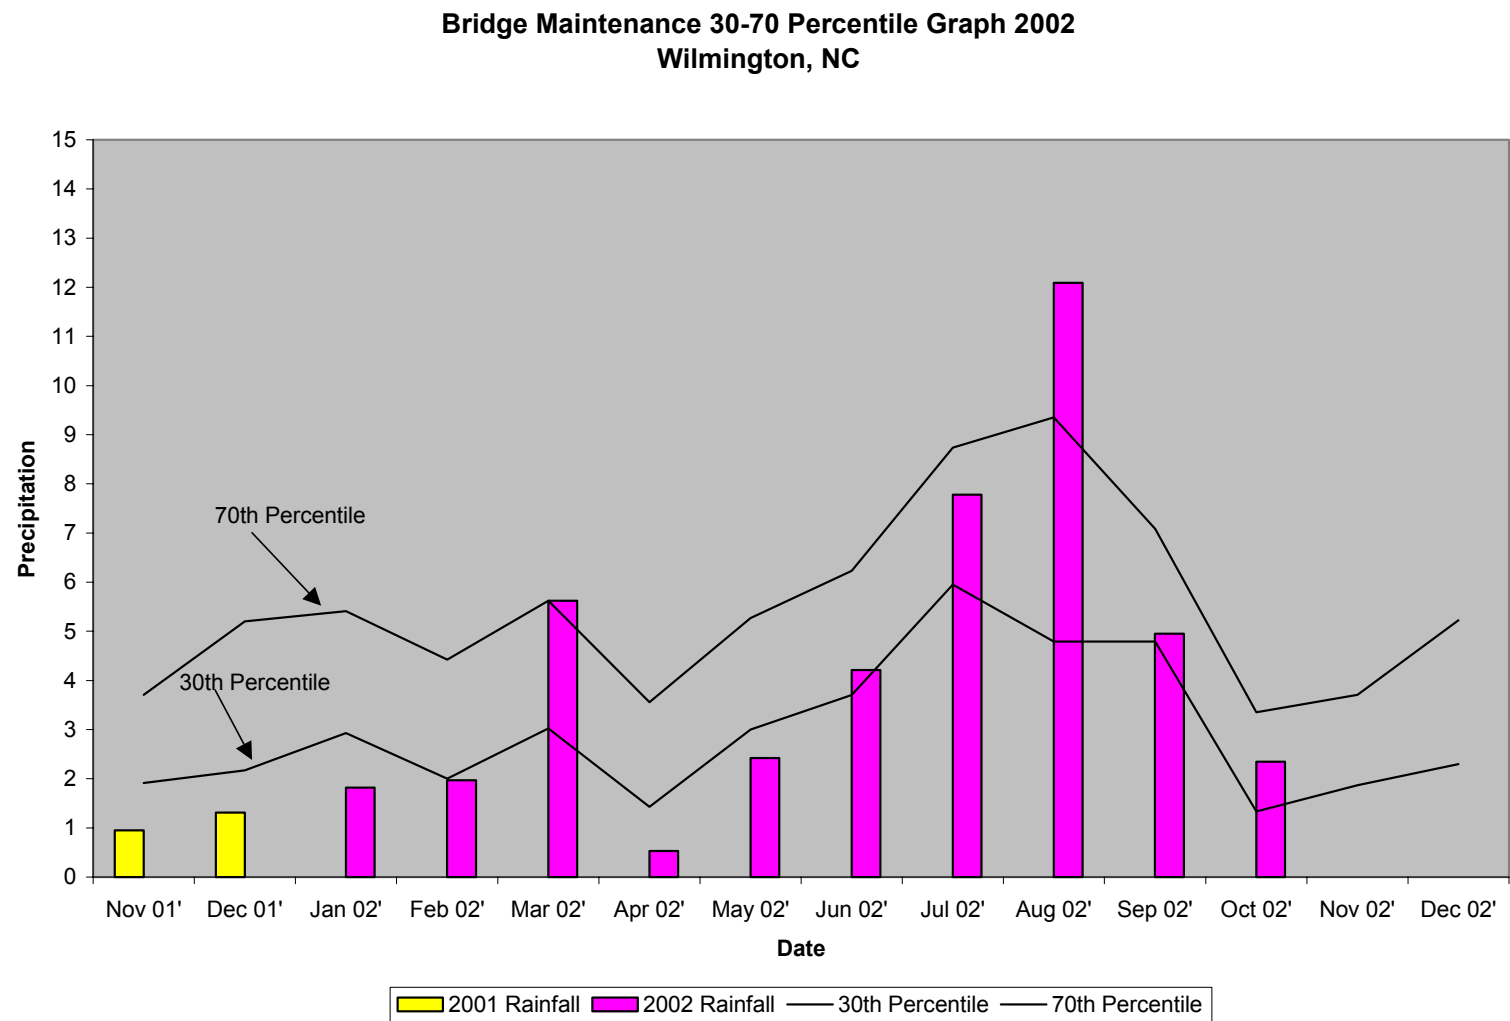
FIGURE 3: 2002 30-70 Percentile Graph

Figure 3 represents an examination of the local climate in comparison with historical data in order to determine whether 2002 was “average” in terms of climate conditions. The two lines represent the 30<sup>th</sup> and 70<sup>th</sup> percentiles of monthly precipitation for Wilmington, NC. The bars are monthly rainfall totals for 2001 and 2002. The historical data was collected from the State Climate Office of North Carolina.

The months of July, September and October were considered “average”. November 01, December 01, January, February, April, May, and June were considered below “normal”. March and August were above “normal” months. Overall the site experienced below average rainfall in 2002

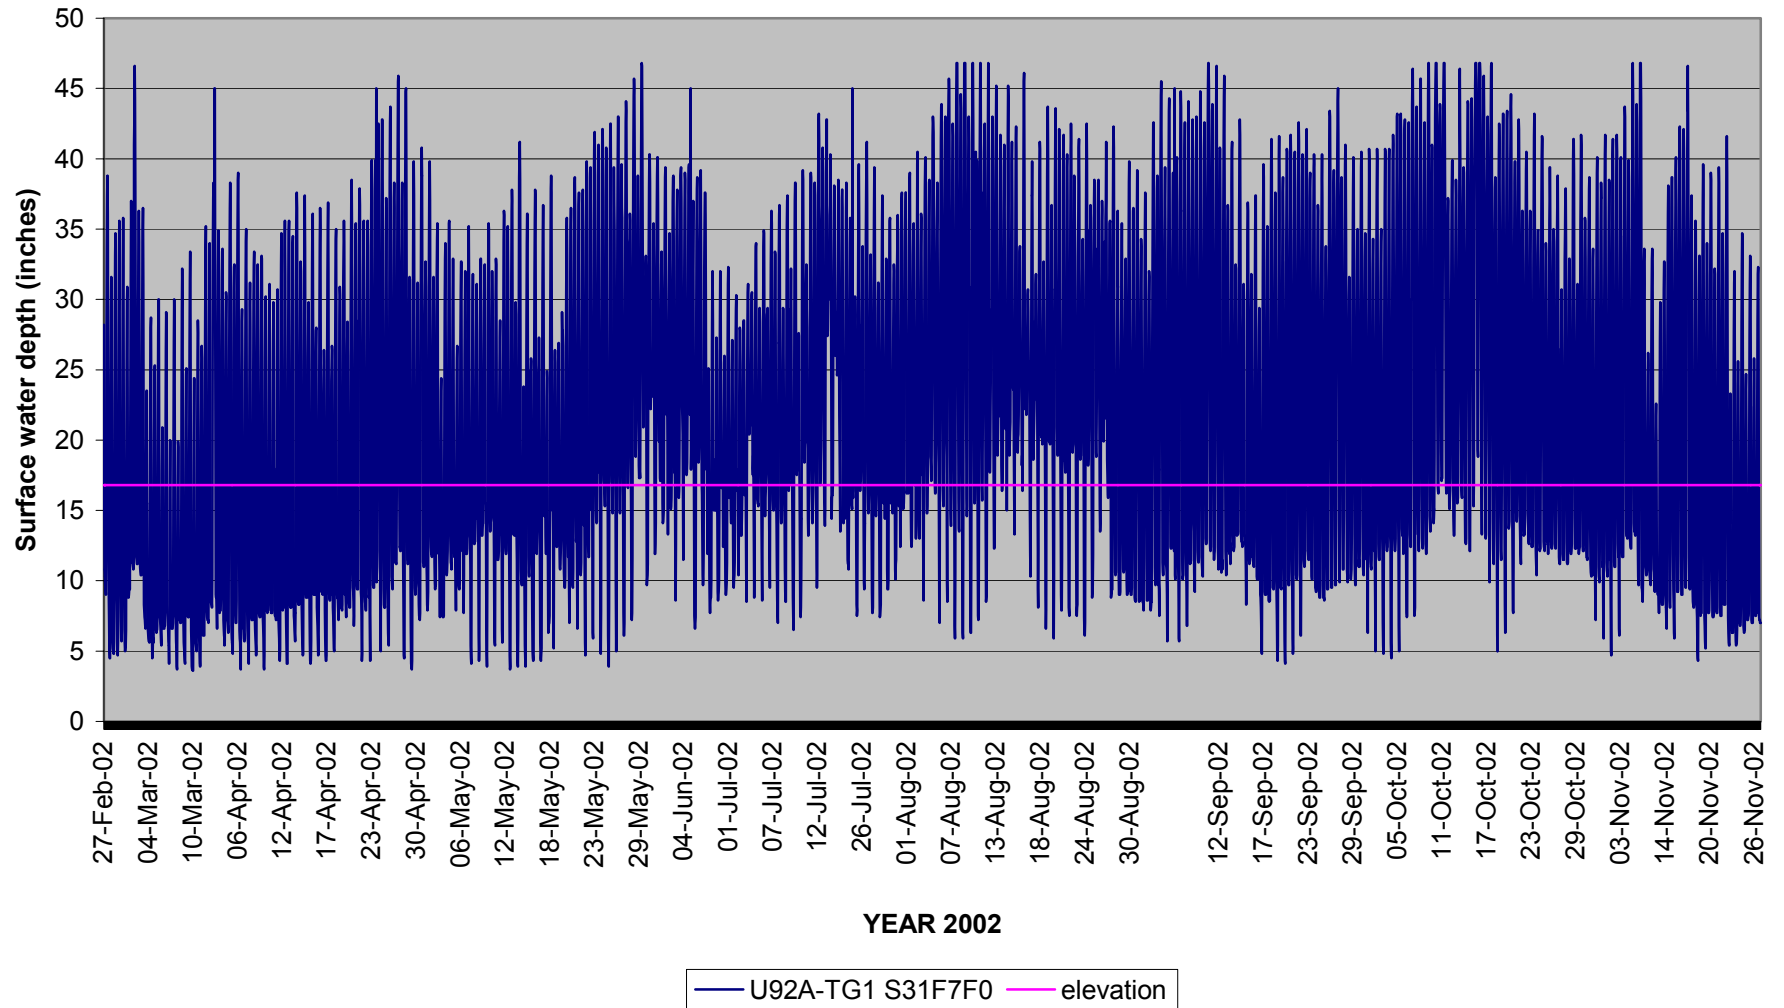
**Bridge Maintenance  
U92A-TG1 S31F7F0**

Appendix A contains a plot of the water depth for the surface gauge. Monitoring results are shown for the growing season for the 2002 monitoring period. The actual average elevation across the site (16.8 inches) is also shown on this graph, calculated from elevation data taken on the same day that the elevation of the surface water gauge calibration point was determined.

The surface water gauge on the site recorded water levels greater than the actual average site elevation (16.8 inches above sea level) for 59.7% of the monitoring period (February through November, excluding missing data intervals).

The Bridge Maintenance Mitigation Site met the hydrologic success criterion during the 2002 monitoring period.
